xEMU Thermal Vacuum Testing Overview

The Exploration Extravehicular Mobility Unit (xEMU) project was the culmination of over a decade of spacesuit development that was performed in-house at the NASA Johnson Space Center. This project reached a level where almost fully completed development fidelity spacesuits had been designed, assembled, and tested in an integrated configuration. The xEMU Design-Verification-Test (DVT) hardware was assembled into two different xEMU test articles and underwent a series of thermal-vacuum tests at the Johnson Space Center's Chamber B. These tests not only gathered data on thermal performance, but also exercised the life support system, communication system, suit information systems, and suit avionics. This complex test has and will continue to produce many meaningful reports ranging from component level test results (for example on spacesuit boots), test design of heater cages to simulate thermal environments for a spacesuit test article, and higher level thermal performance of subsystems (such as the Portable Life Support System) or the entire assembly. This paper provides an overview of the test configuration and also top-level results from this h

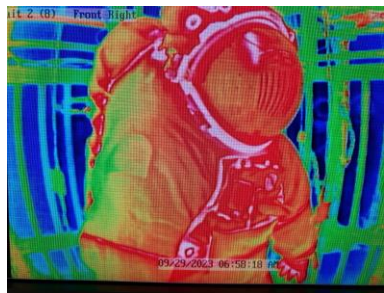
Figure 3. Suit 2 Thermal Image.

Figure 3 shows an infrared image of Suit 2 during testing. This test series consisted of mapping the performance of the xEMU across as wide of a temperature range as possible. This included mapping performance of the life support system components in different thermal environments, evaluating consumables usage, abort capabilities with the Auxiliary Thermal Control Loop (ATCL) and Secondary Oxygen Assembly (SOA), demonstrating Caution and Warning System (CWS) operation, and demonstrating the xINFO system (lights, camera, and telemetry transmission over Wi-Fi). Performing these simulated EVAs also enabled verification of numerous thermal models and performance of the Environmental Protection Garment (EPG). Heat transfer from the suit to the environment was estimated for different thermal environments and internal suit temperatures were checked against safe touch temperature limits for crew. The Suit 2 boots were in contact with the floor of the chamber, which was also cooled with liquid nitrogen and provided a unique and challenging boot thermal test.

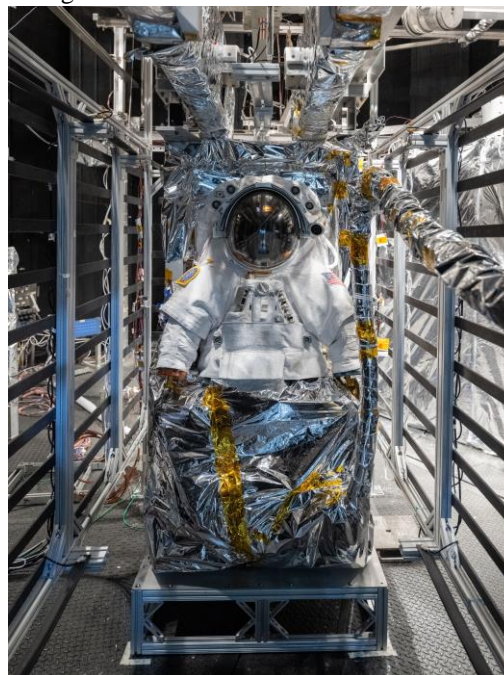
Figure 2. SxEMU Test Article.

This paper provides an overview of these xEMU thermal-vacuum tests. Two xEMU test articles were used. The SxEMU, pictured in Figure 2, used this SxEMU configuration which included a full xPLSS, aluminum Hard Upper Torso (HUT), helmet assembly, xINFO lighting band and camera, and test equipment to simulate human metabolic products. A second test article, Suit 2, which is pictured in Figure 1, did not have an xPLSS but instead included a full xPGS to better capture the total heat exchange between the suit and the environment. Many additional papers, references 1 through 11, provide lower level details of specific aspects of xEMU performance. These include details on boot thermal performance, audio subsystem performance, or heat rejection performance. This paper provides an

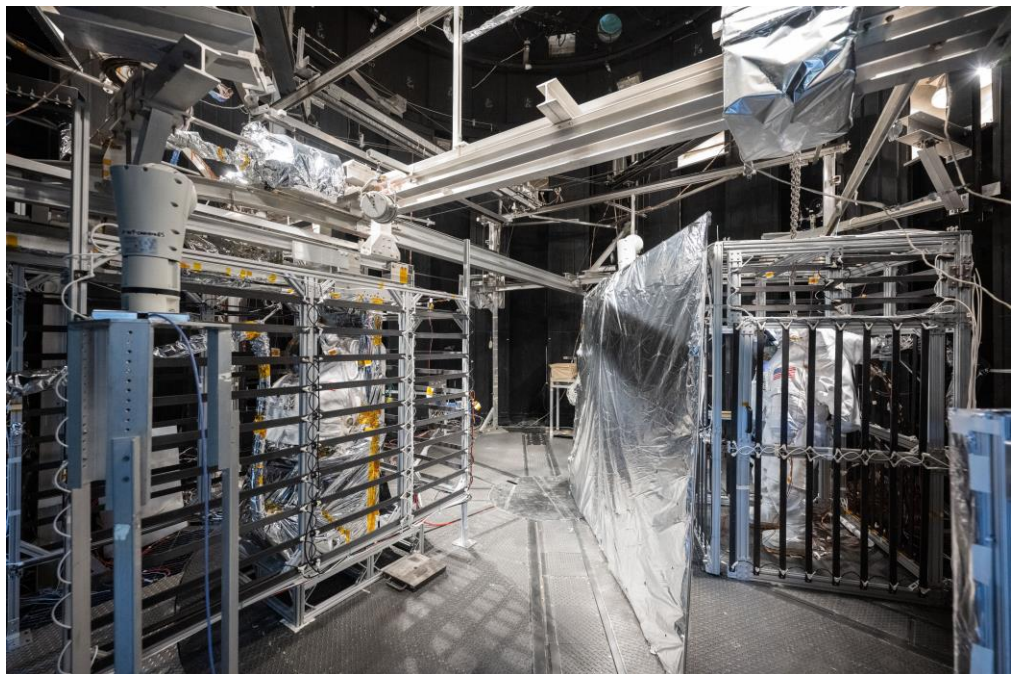
Figure 4. xEMUs in Chamber B.

Both xEMUs were located in Chamber B inside of heater cages, as seen in Figure 4. A large mylar curtain was placed in between the two suits to minimize thermal interactions between the two test articles. The SxEMU is on the left and the Suit 2 test article is on the right.

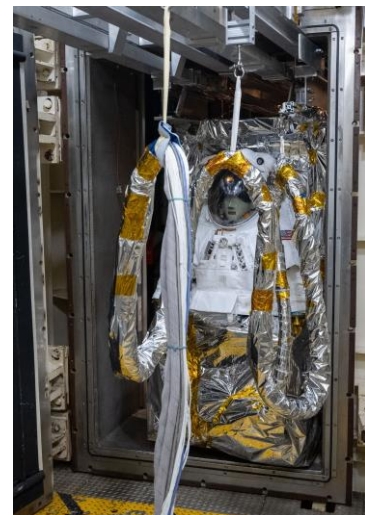
Figure 6 shows the SxEMU traversing between the chamber manlock and the main vacuum chamber. Chamber B has a crew transport system that has previously been used to help crew members wearing heavy spacesuits to travel in and out of the chamber. For this test, the same overhead rail system and chain drive were used, but the test article support stand, and test umbilical were modified to support this unmanned test. The test umbilical provided power, data, and gas supplies to a human metabolic simulator (HMS) located under the SxEMU test article and also to an internal instrumentation package inside of the SxEMU test article. The HMS consisted of flow controllers for CO₂ and water, an evaporator, and flow controllers to pull gas from the SxEMU to simulate oxygen consumption by a crew member or simulated suit purge valve operation. Inside of the HUT, the internal instrumentation included an audio manikin, three measurement microphones, two accelerometers, and a set of instrumentation to monitor xPLSS performance. Figure 7 shows how the data collection system, CO₂ sensor, NH₃ sensor, humidity sensors, pressure sensors, flow sensors, and temperature sensors were packaged to fit inside of the SxEMU. This internal instrumentation package closed the Primary Thermal Control Loop (PTCL) and ATCL where

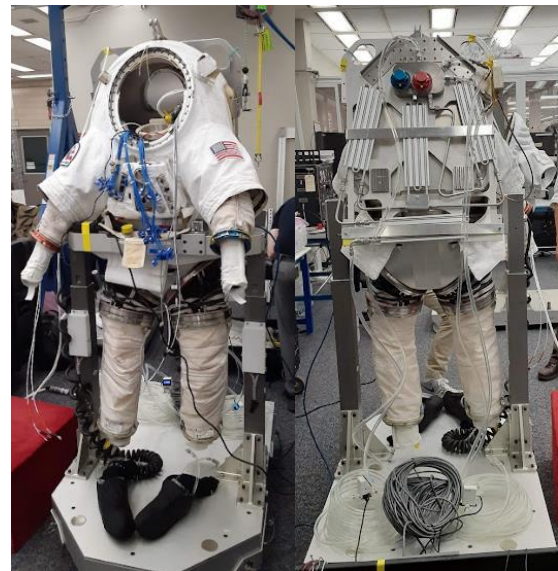
Figure 9. Suit 2.

Suit 2 provided a full xPGS test article and an improved opportunity to assess the full suit heat exchange with environments of different temperatures. Figure 9 shows Suit 2 in a partially assembled state. It included a weight relief plate, where the xPLSS would normally be installed, to suspend the xEMU from an overhead I-beam inside of the chamber. Inside of the suit was a manikin wearing an LCVG. This provided a high fidelity thermal boundary on the inside of the suit to assess the heat transfer through the suit to the environment. Modifications were made to the LCVG to better represent a crew member's hands and feet. These are shown in Figure 10. Normally the LCVG does not cover hands and feet, but in order to provide some thermal interface inside of the gloves and boots of the suit, extra tubing was added to the fluid loop and sewn into comfort gloves and around socks to simulate the temperature of a crew members hands and feet.
